**USEPA – Region 4
Superfund Site Inspection Report
Hurricane IRMA Follow-up**

Site: Pickettville Road Landfill

Location (City/State): Jacksonville, Florida

Date of Inspection: 09/14/2017

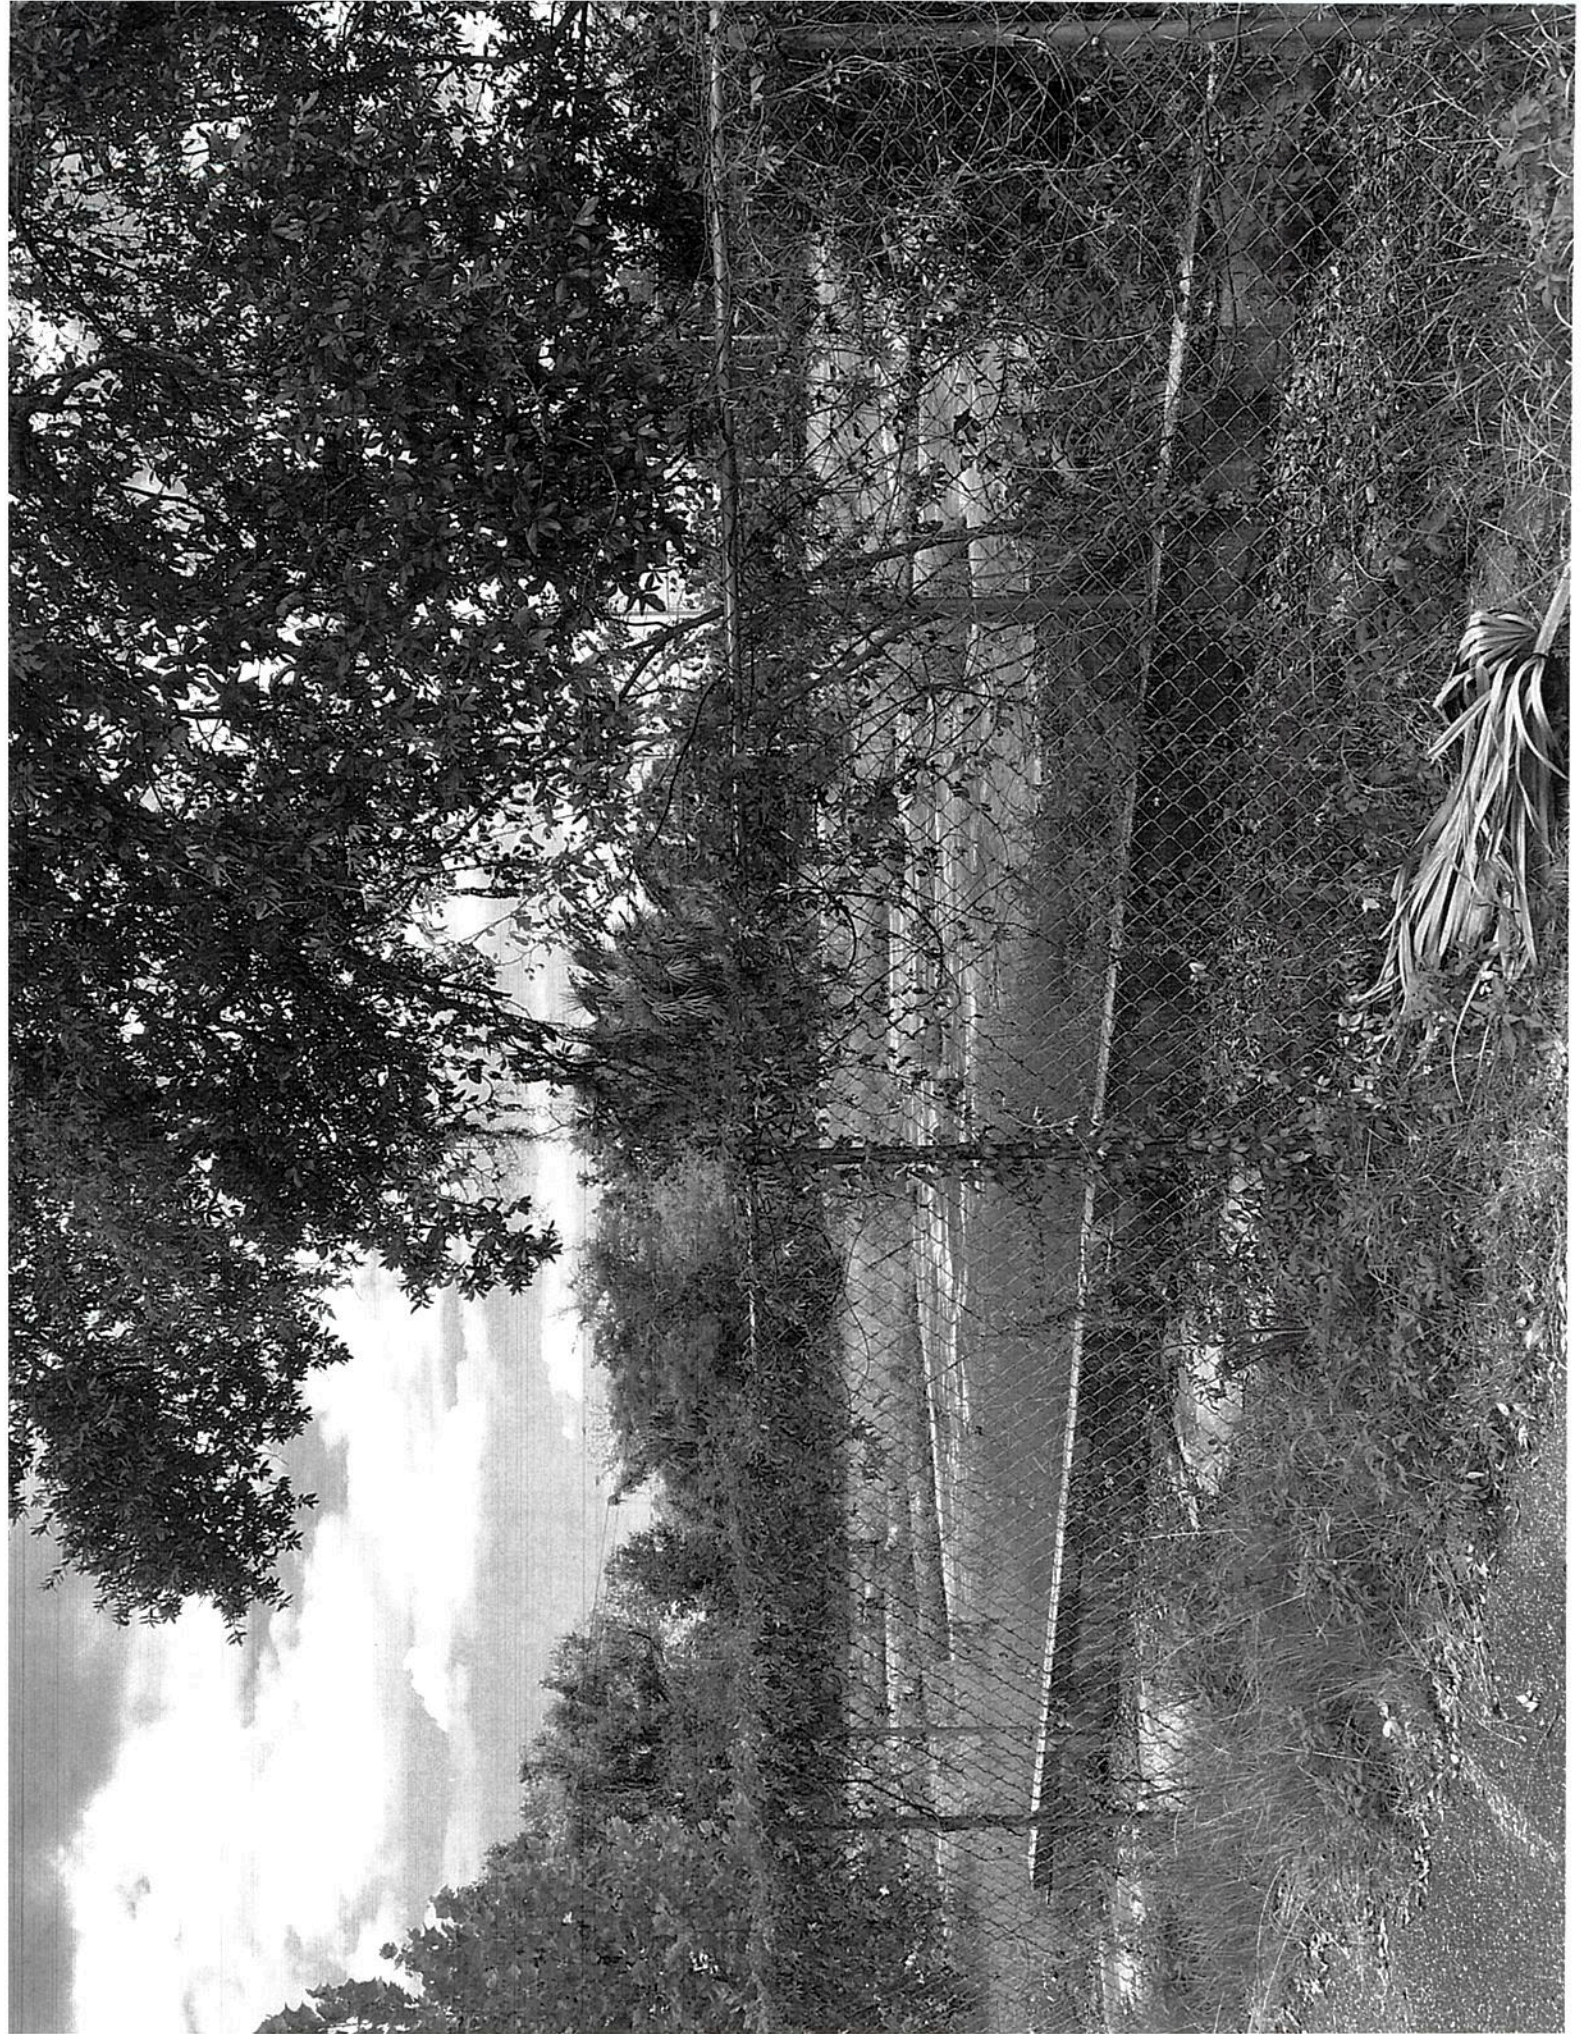
Additional Comments: Site consists of numerous properties (primarily residential) throughout the City of Jacksonville. Inspection team drove around the area and noticed falling trees and saturated grounds. Some properties were substantially flooded. Wet and damaged household items and furniture were observed on the curb.
